DEGRADATION OF LANDSCAPE IN SERBIAN SKI RESORTS-ASPECTS OF SCALE AND TRANSFER OF IMPACTS

Ratko Ristić¹, University of Belgrade, Faculty of Forestry, Belgrade, Serbia
Nevena Vasiljević, University of Belgrade, Faculty of Forestry, Belgrade, Serbia
Boris Radić, University of Belgrade, Faculty of Forestry, Belgrade, Serbia
Sandra Radivojević, State Owned Company "Ski Resorts of Serbia", Belgrade, Serbia

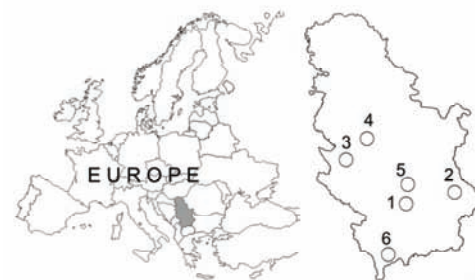
Figure 1 – Disposition of main ski resorts in Serbia (1-Kopaonik; 2-Stara Planina; 3-Zlatibor; 4-Divčibare; 5-Goč; 6-Brezovica)

In former development of mountain areas a few ski resorts were formed (*Figure 1*). A major and the oldest ski resort in Serbia is located on the Kopaonik mountain, in the area of the National Park. This ski resort offers about 50 km ski slopes for alpine skiing, about 18 km ski slopes for cross-country skiing, interconnected with 24 chairlifts and ski lifts. The total investment in the construction of new ski runs

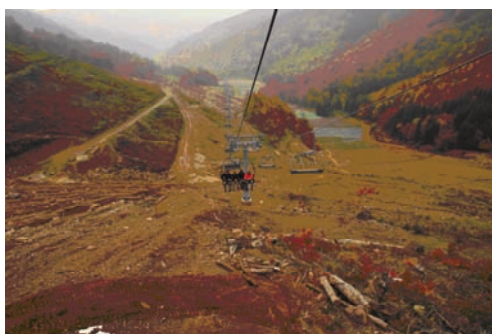
Figure 2 – Anthropogenic bare land on Stara planina

impacts have been noticed in another ski resorts. The hardest forms of terrain degradation were recorded in the proximity of locality Babin Zub, in the zone of ski runs, ski lifts and access roads. Destruction of autochthonous beech forest and meadows (over 1600 m.a.s.l.) produced anthropogenic bare land as dominant surface in upper part of Zubska river watershed (Figures 2, 9). Intensive erosion processes caused appearance of furrows and gullies, almost 3.5m deep (Figure 4).

negative impacts have strong, synergy intensity, thus creating conditions for extreme spatial destruction (Figures 2-5).

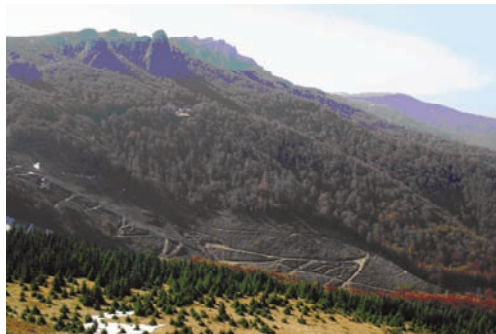
Figure 3 – Network of access roads

gravitates to Zubska river and its tributaries, has expressive slope of terrain ($I_m = 47.57\%$), and erosion products reach ski runs or hydrographic system very easy. Fast surface runoff accelerates transport process. Network of access roads (Figure 3) helps concentration of runoff: roads had been built without asphalt cover and structures for evacuation of water: road culverts and channels. Fast concentration of rainfall water increases frequency of torrential floods, with high content of sediment (Figures 6, 7).

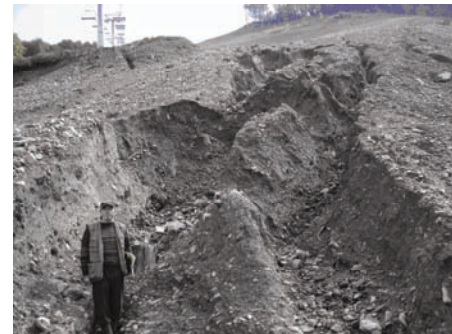
Figure 4 – Deep gullies on ski run „Konjarnik 2“ (Stara planina)

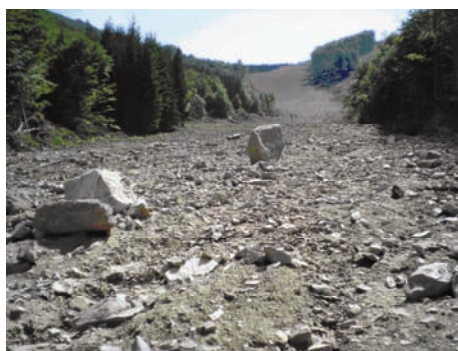
Figure 5 – Products of erosion on ski run „Konjarnik“ (Stara planina)

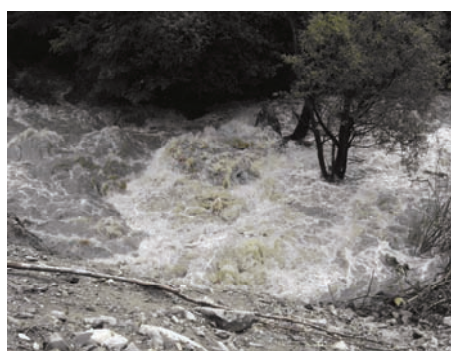
Figure 6 – Torrential flood in Zubska river bed

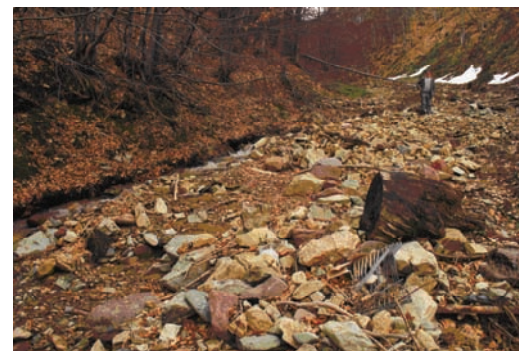
Figure 7 – Deposition of bed load in Zubska river bed

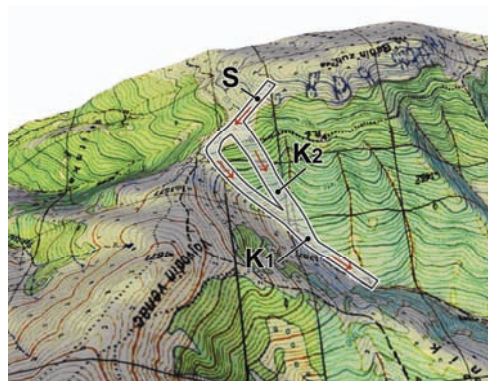
Figure 8 – Disposition of ski runs on Stara Planina

Ski resort „Stara planina“ was formed in upper part of the Zubska river watershed, on very steep terrain, in the area with a few local streams (Figure 8).

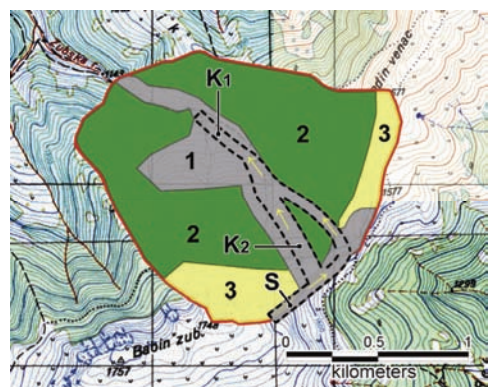
Figure 9 – Composition of surfaces on upper part of Zubska river watershed (1-anthropogenic bare land; 2-forest; 3-meadows)

Destruction of vegetation cover (forest and meadow stands) caused hard soil degradation (humus-silicate soil; red sand skeleton), thus creating unfavorable composition of surfaces (Figure 9), with 46 hectares of anthropogenic bare land (almost 25% of Zubska river watershed, in relation to profile in the proximity of ski run „Konjarnik 1“, about 1.5 km far away from peak point).

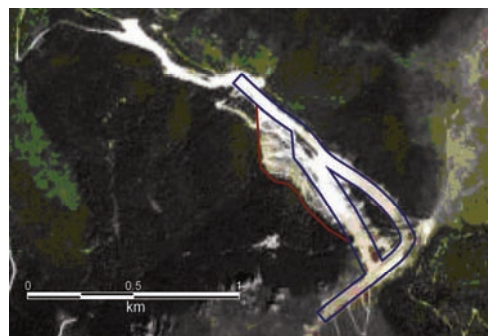
Figure 10 – Immediate zone of ski resort „Stara Planina“

Next forms of degradation were noticed in immediate zone of ski resort (Figure 10):

- destruction of vegetation cover (forest and meadow stands);
- endangering of animal and plant species;
- excessive erosion (network of furrows, deep gullies, shallow land slides, debris flows);
- intensive production of erosive material and fast transport to hydrographic system;
- fast forming of torrential flood waves;
- degradation of visual and aesthetic characteristics of landscape.

Immediate zone of ski resort comprises spatial diameter of about 1.5 km (Figure 10). Elements of degradation are easy noticeable,

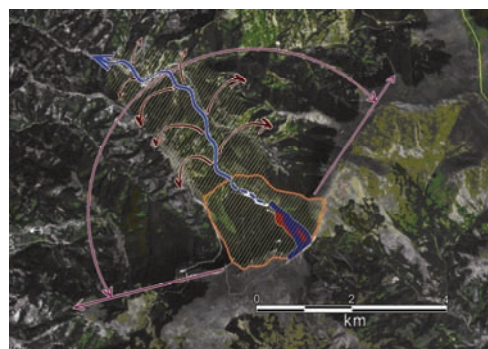
Figure 11 – Wider zone of ski resort „Stara Planina“

Next forms of degradation were noticed in wider zone of ski resort (Figure 11):

- more frequent appearance of torrential floods;
- increased concentrations of sediment and pollutants in streams;
- endangering of road system and residential objects;
- disturbing of common economy activities of local dwellers.

Wider zone of ski resort (Figure 11), comprises spatial diameter of about 5 km. Elements of degradation are not easy noticeable, negative influences dominate in the zone equivalent to narrow zone of ski resort (source of impacts and starting area for their transfer). Anthropogenic bare land takes less than 5% of Zubska river watershed (in the relation to the profile 4.7 km far away from the peak point), but it is zone of forming torrential flood waves. Transfer of impacts is going on through Zubska river bed, with following effects: demolishing of bridges; fulfillment of road culverts by sediment; destruction of road system. Entire area is very isolated (the nearest small city is Knjaževac, 60 km far away), and in this way becomes additionally marginalized with interruptions of already weak economical activities. Visual degradation of landscape is noticeable from remarkable view points of neighboring relief.
